When compressor seals act like bearings

by Kevin G. Farrell Turbomachinery Vibration Specialist Bently Nevada Corporation St. Petersburg, Florida

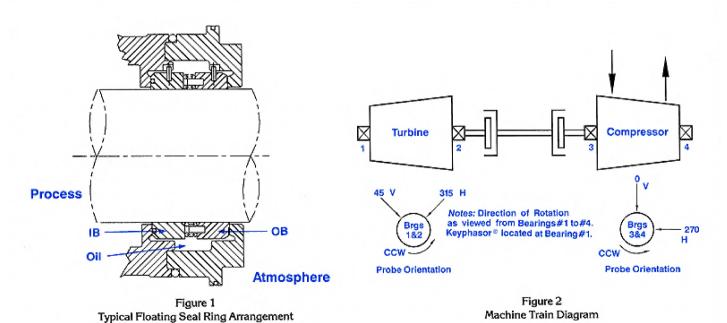
his case history documents a phenomenon occasionally found in machinery utilizing bushing-type oil film process gas seals. By design, this type of seal is intended to float radially (Figure 1). In certain applications, however, the seal may lock up and behave as an externally-lubricated bearing which can unload the tilting pad bearings and change the balance resonance speeds significantly. In this case, the first balance resonance speed is at the midpoint of the governor speed range for this machine.

First, it is important to understand how the seal can be involved with the shaft dynamics. The process (hydrogen) is inboard of the seal assemblies (Figure 1). There are also labyrinth seals just inboard of each floating seal ring assembly. Labyrinth seals are not shown and are not considered in this discussion. Also, aerodynamic seals are not considered here.

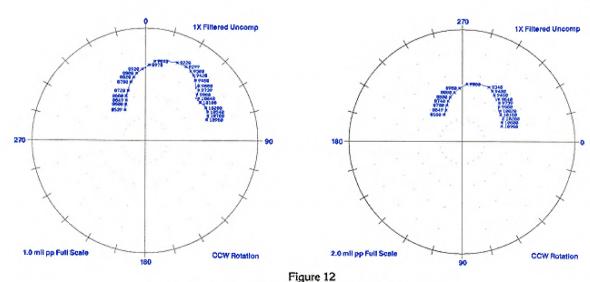
Inboard and Outboard compressor variable speed test results

Subsequently, a variable speed test was performed increasing compressor rpm from 8,330 rpm to 11,000 rpm (Figure 12). This test verified that the balance resonance speed was in the range of 8,800-9,200 rpm. This speed range is also the normal operating range for the compressor. The compressor rotor is being supported by the outboard seal rings as well as the tilting pad bearings at each end of the rotor.

Continued operation may occur without incident except that premature seal ring wear is expected due to heavy radial loading. In similar applications, when oil seals influence the compressor rotor-dynamic response, gas seal technology has proven to be an alternative to consider. Dry gas seals use the process gas as a buffer gas that separates the stationary and rotating elements of a face seal. The plant is currently investigating the use of dry gas seals to avoid operating this compressor near the balance resonance speed.
